## PHOTOGRAPHIC EVIDENCE REPORT

### COLD WATER STORAGE TANK (CWST) REFURBISHMENT WORKS (DOMESTIC COLD WATER SERVICES)

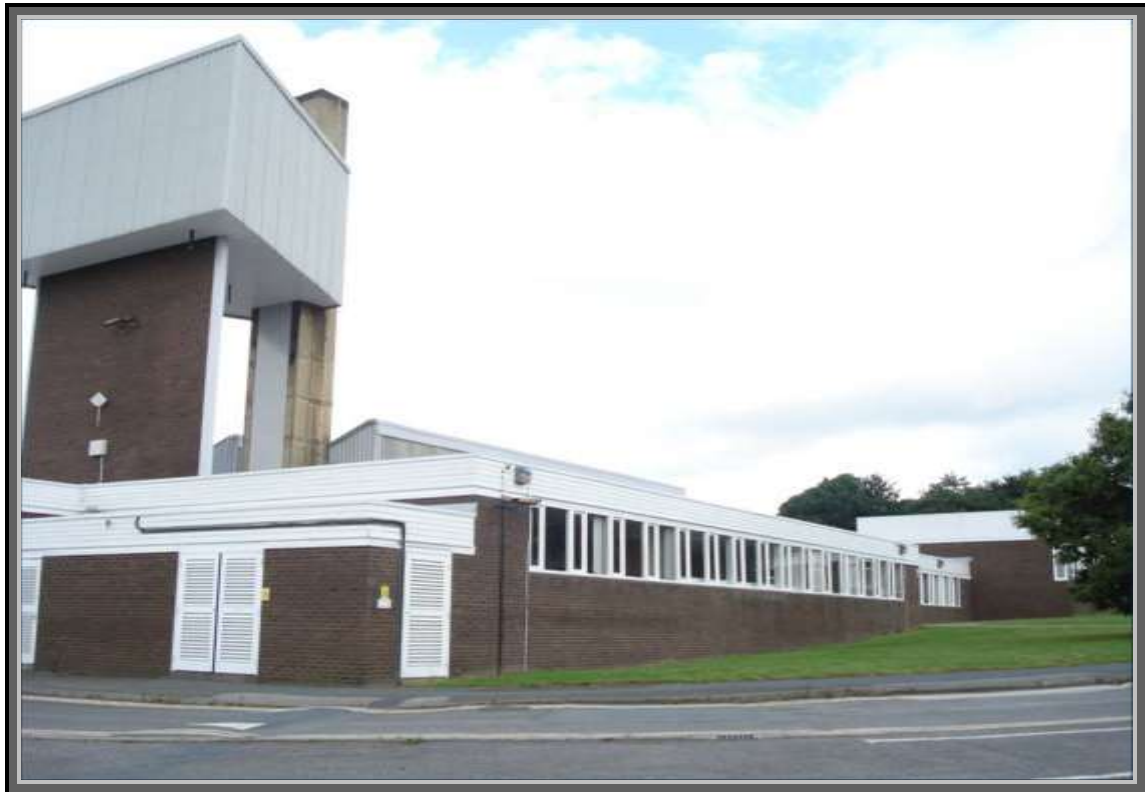
**External picture of Tank Tower (20m high from ground level)**

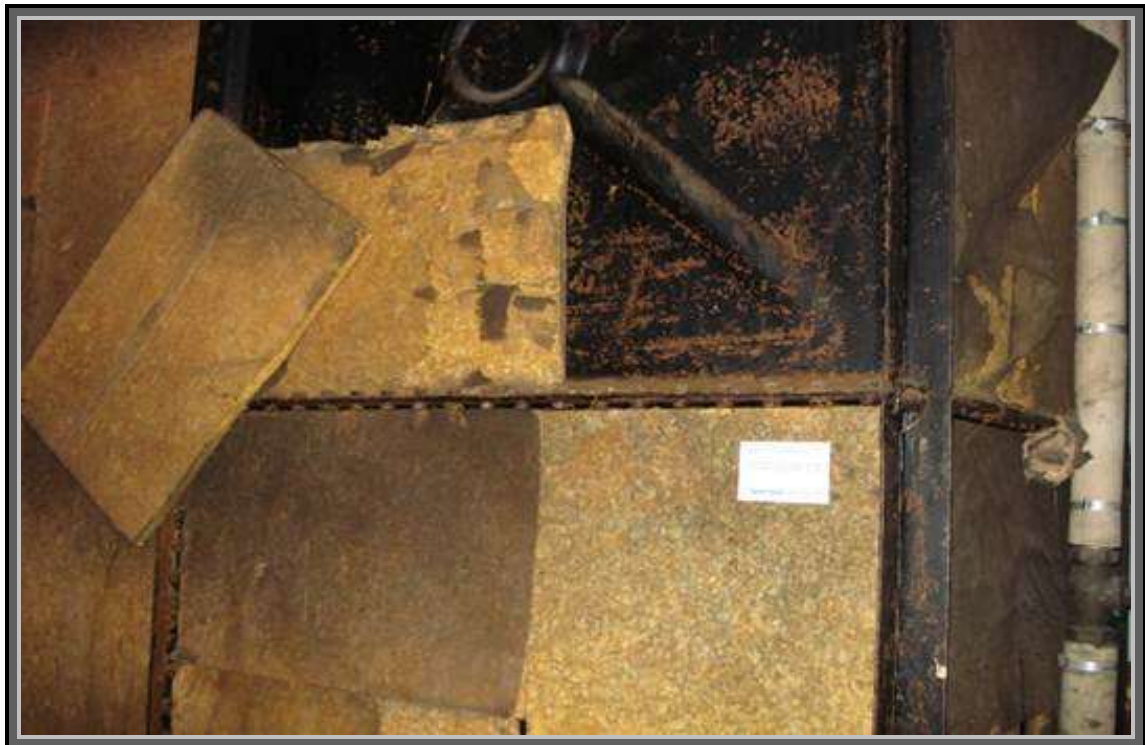
**External picture of CWST within the Tank Tower**

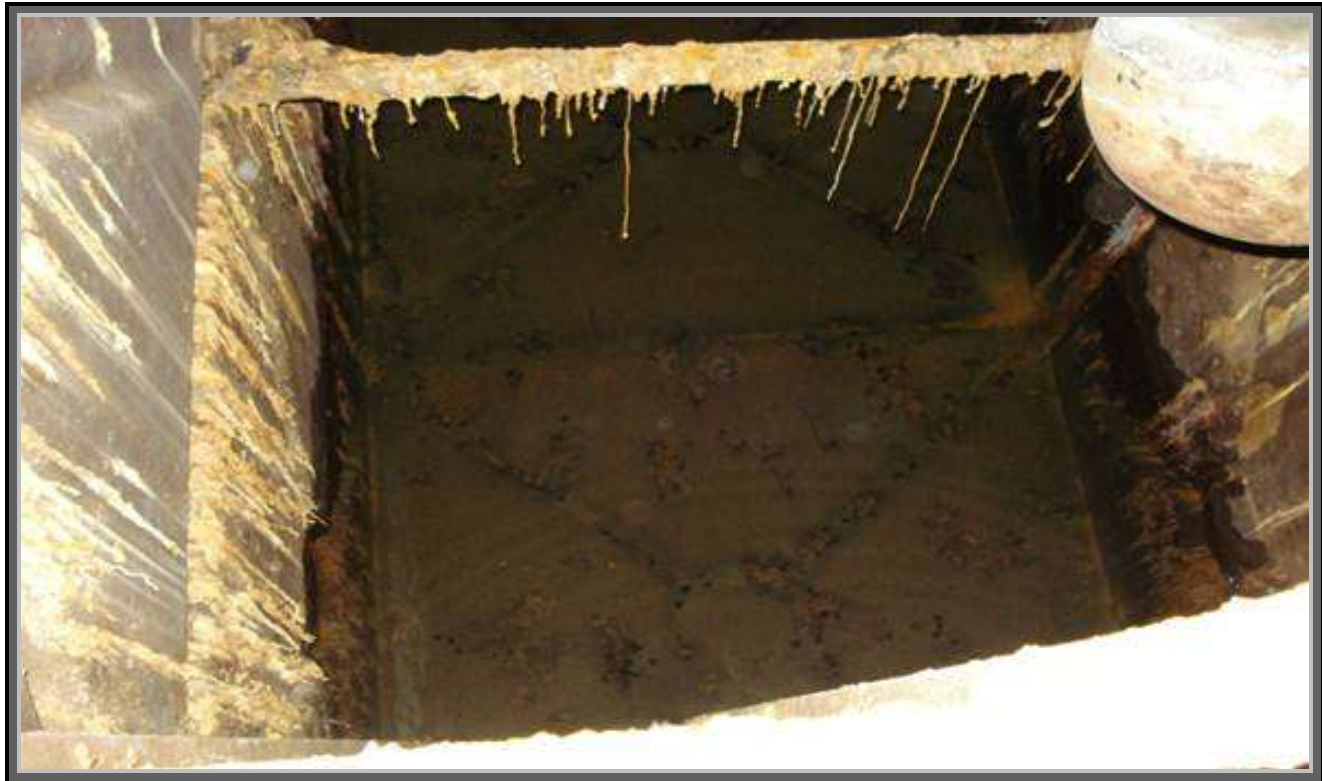
**Internal picture taken of the CWST**

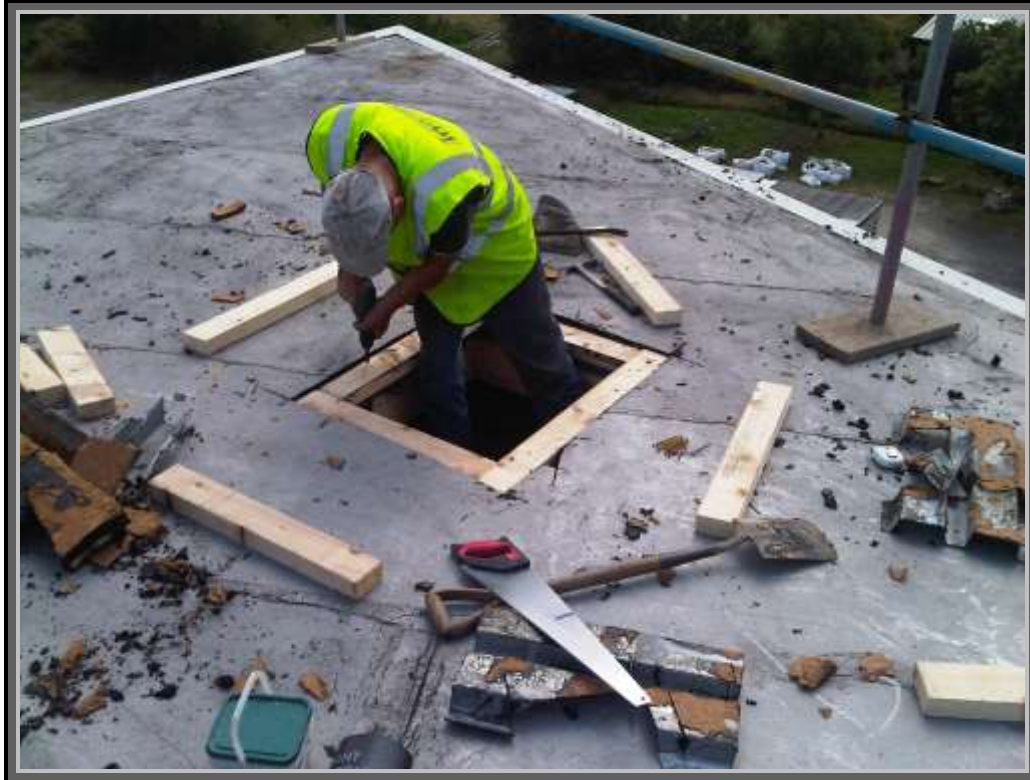
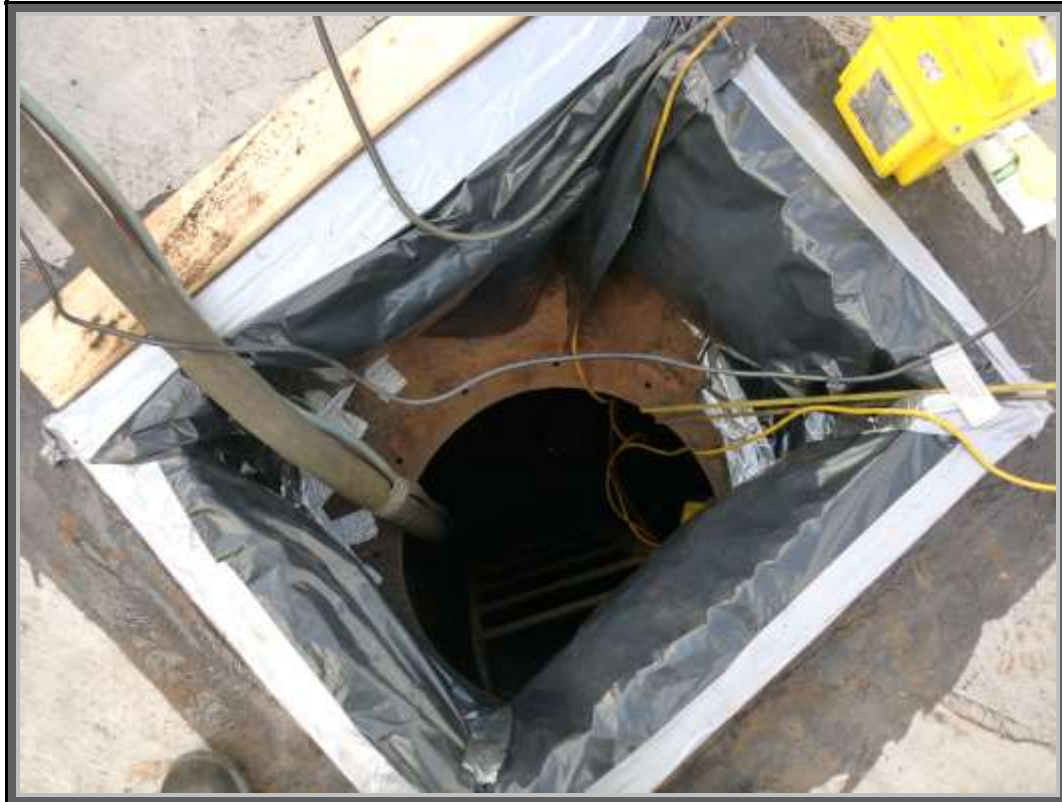
**Internal condition of CWST once fully drained down**
